January 31, 2018
Project No. 17-1381

Subject: Preliminary Fault Investigation
Proposed Kensington Essential Services Building
217 Arlington Avenue
Kensington, California

Subject: Geophysical Investigation Results
Kensington Public Safety Building
217 Arlington Avenue
Kensington, California

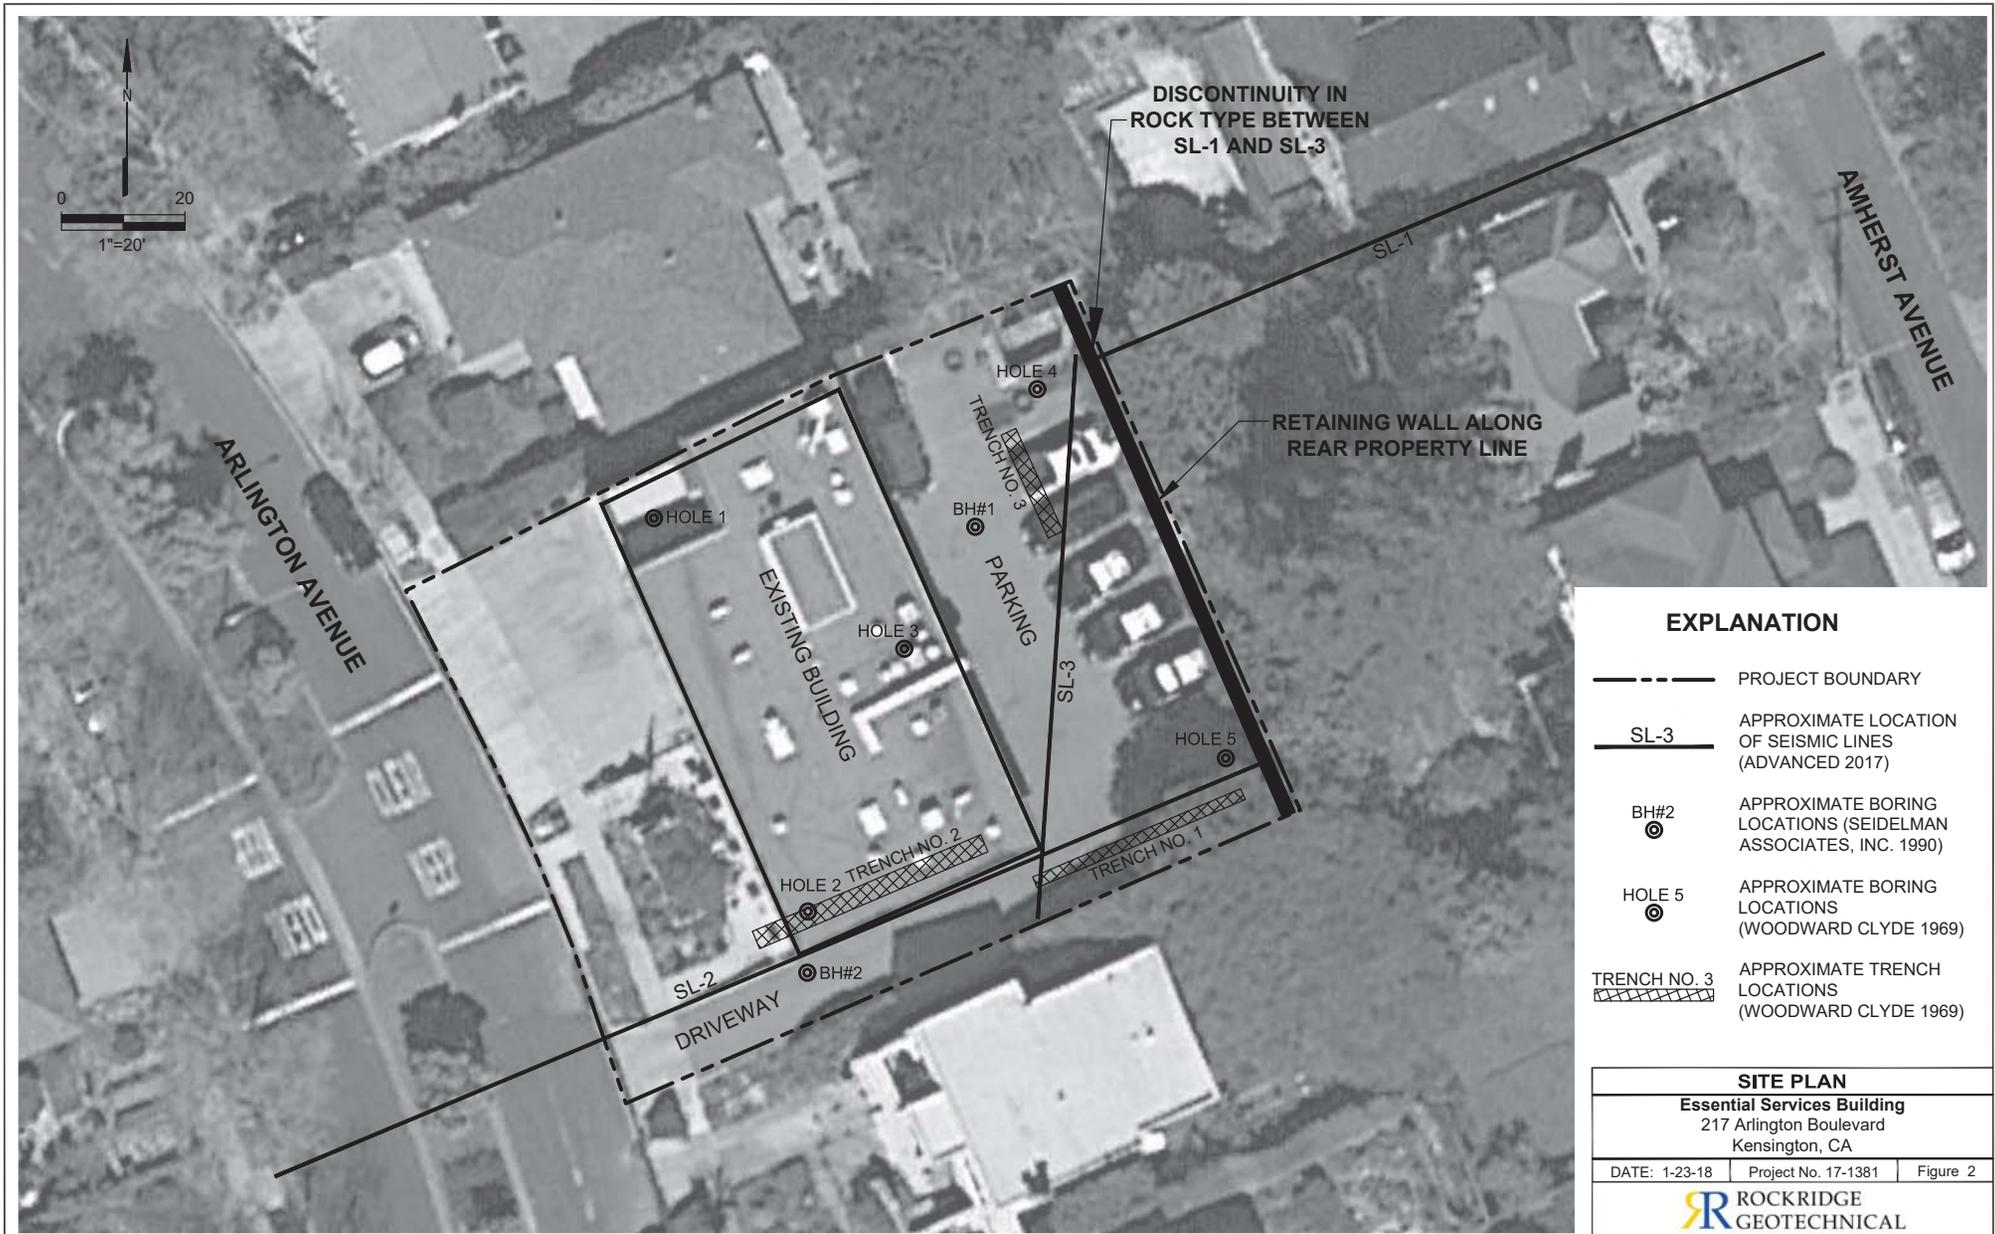
SITE PLAN

recommendations for site development. However, the investigation trenches (T-1 and T-3) did not reveal continuous in-place bedrock upslope of the existing building that will be within the footprint of the proposed new building. The approximate locations of the Woodward-Clyde trenches and borings are shown on Figure 2.

In 1990, Seidelman Associates, Inc. performed a geotechnical study to evaluate reported ground settlement at the site. The study included drilling two borings and installing slope inclinometers to monitor for subsurface landslide movement. The study did not address fault locations. The approximate locations of the Seidelman Associates borings are shown on Figure 2.

As part of this study, AGS performed three seismic refraction lines at the approximate locations shown on Figure 2. The seismic lines were extended off site to the east and west to gain additional coverage for the fault investigation. Detail descriptions and results of the geophysical survey are presented in Appendix A.

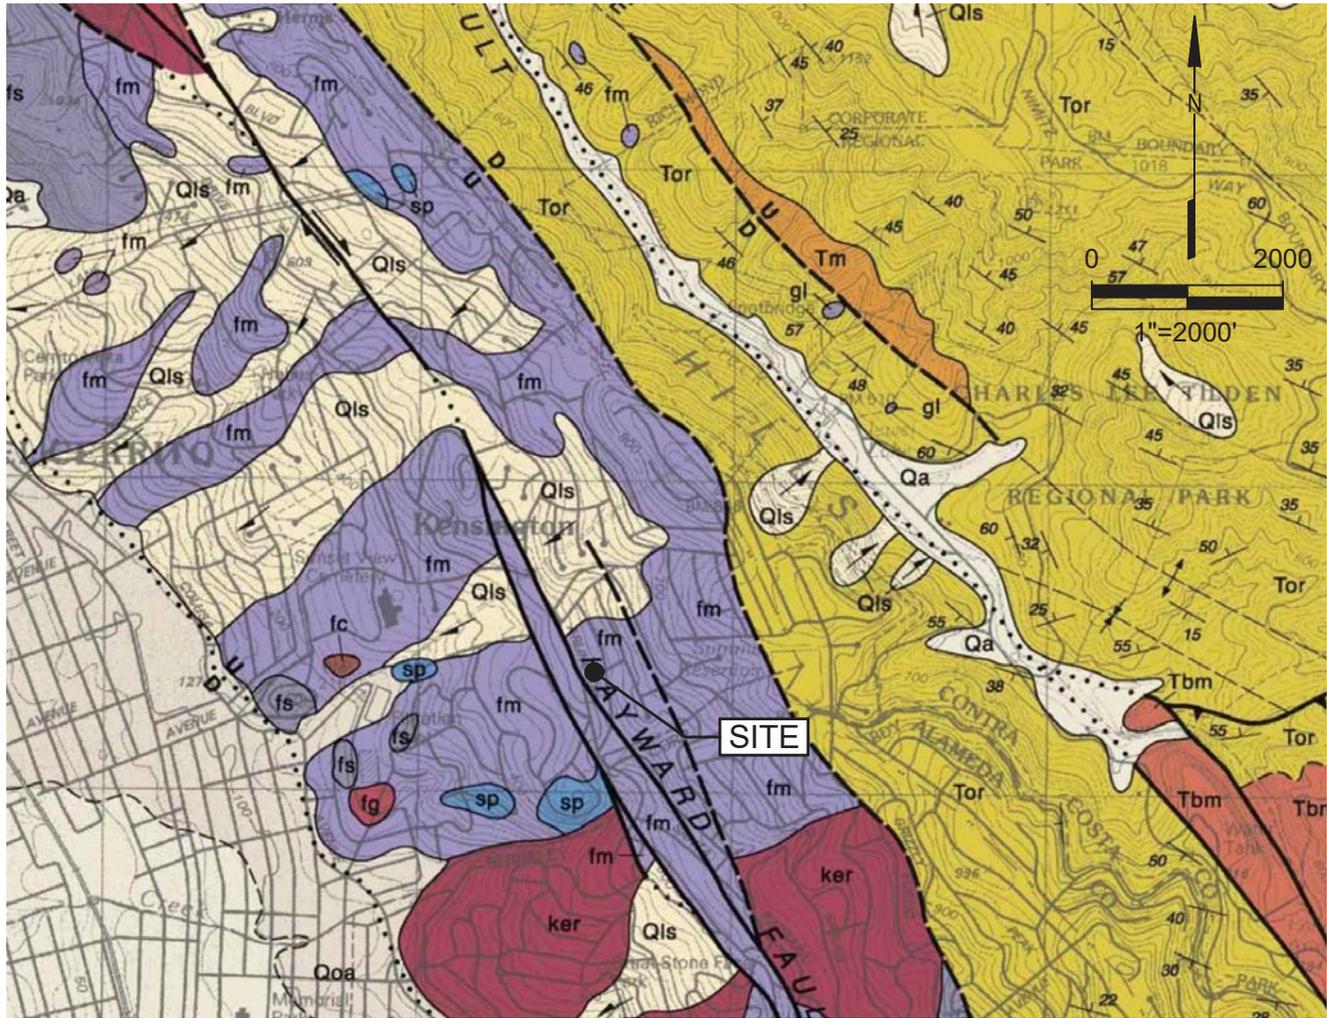
REGIONAL GEOLOGIC MAP		
Essential Services Building		
217 Arlington Boulevard Kensington, CA		
DATE: 1-23-18	Project No. 17-1381	Figure 4

Regional maps indicate that the bands of mélangé are fault-bound blocks oriented in a northwest trend. The map shows faults on both sides of the site. A portion of the geologic map by Dibblee and Minch (2005) is provided on Figure 4.

suspected fault splay upslope of the site near Amherst Way. The geologic map by Dibblee and Minch (Figure 4) also shows three faults near the site, with two (including the main trace) downslope and another suspected splay upslope of the site. The U.S. Geological Survey maintains a data server called the Quaternary Fault and Fold Database (QFFD) that shows the approximate locations of faults in the region. The QFFD (Figure 5) shows two faults, with one fault crossing the center of the site and a fault just upslope of the site above Amherst Way. Note that the QFFD is registered to Google Earth images and are approximate. Additionally, the Tri City Seismic Safety Element report (Figure 6) also shows three faults, with one fault along Arlington Avenue, one fault to the west below Arlington Avenue, and one fault upslope of the site near Yale Avenue.

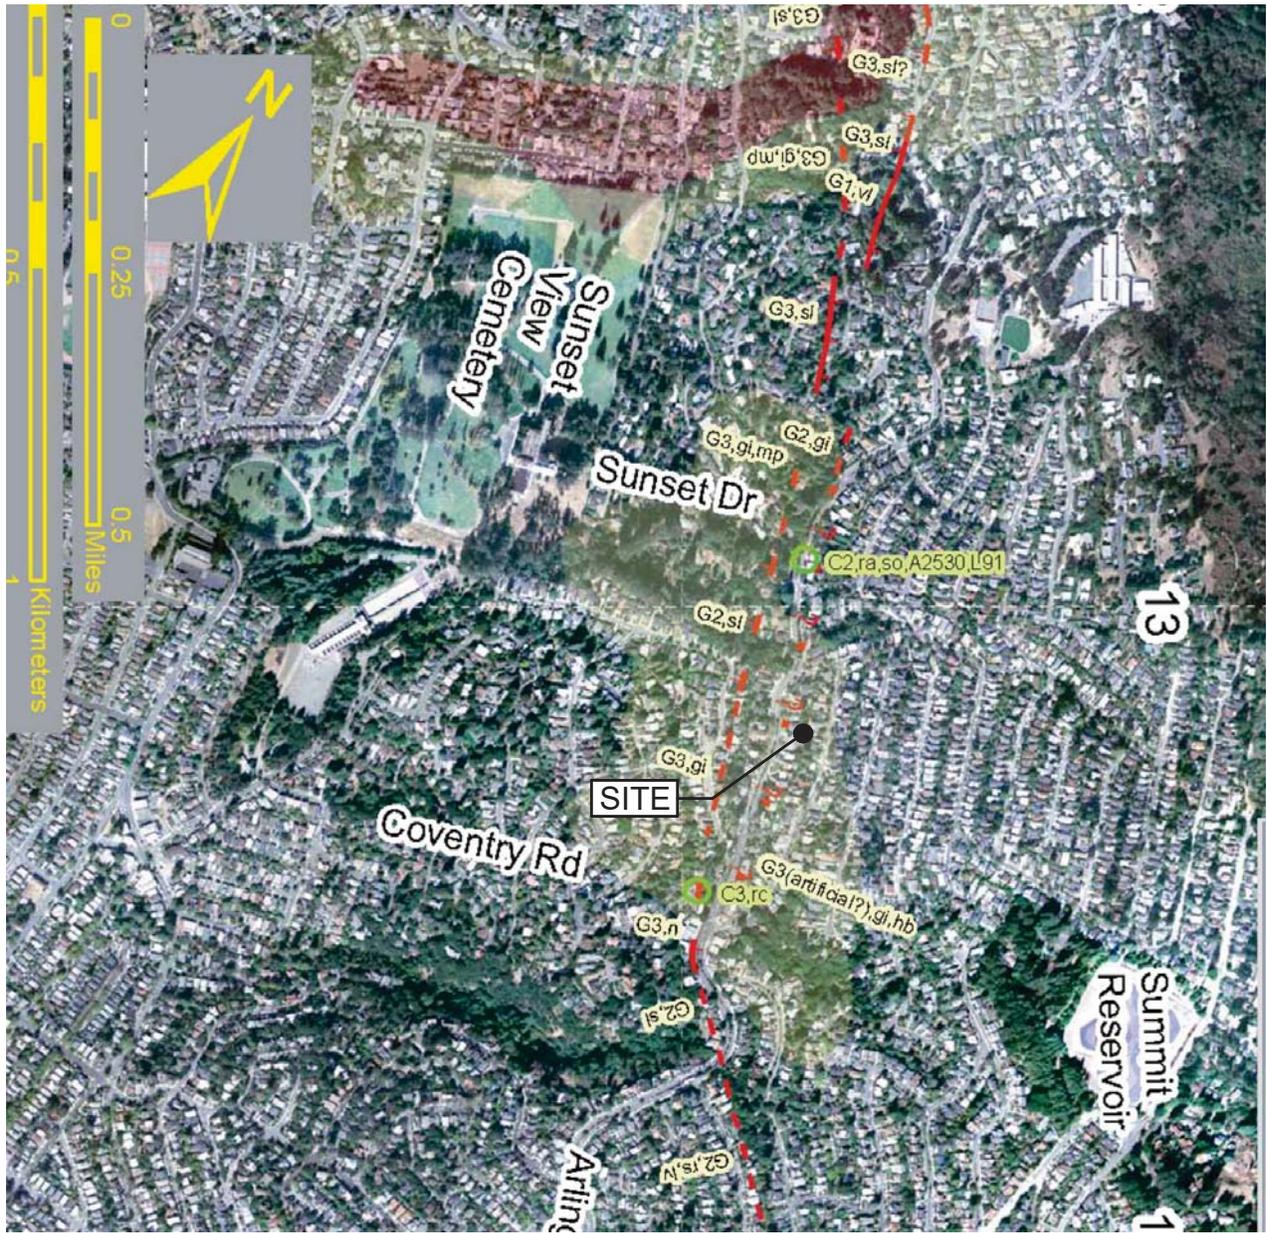
ACTIVE TRACES OF THE HAYWARD FAULT

The currently accepted locations of active traces of the Hayward Fault are shown on maps by the U. S. Geological Survey (Lienkaemper, 2006). The Lienkaemper maps were based on field mapping fault-related deformation such as offset curbs, pavement cracks, linear drainages and other fault-related geomorphic features. The Lienkaemper map shows the main trace of the Hayward fault about 225 feet downslope of the site to the west and a smaller suspected fault splay crossing through the eastern portion of the site as shown on Figure 7.

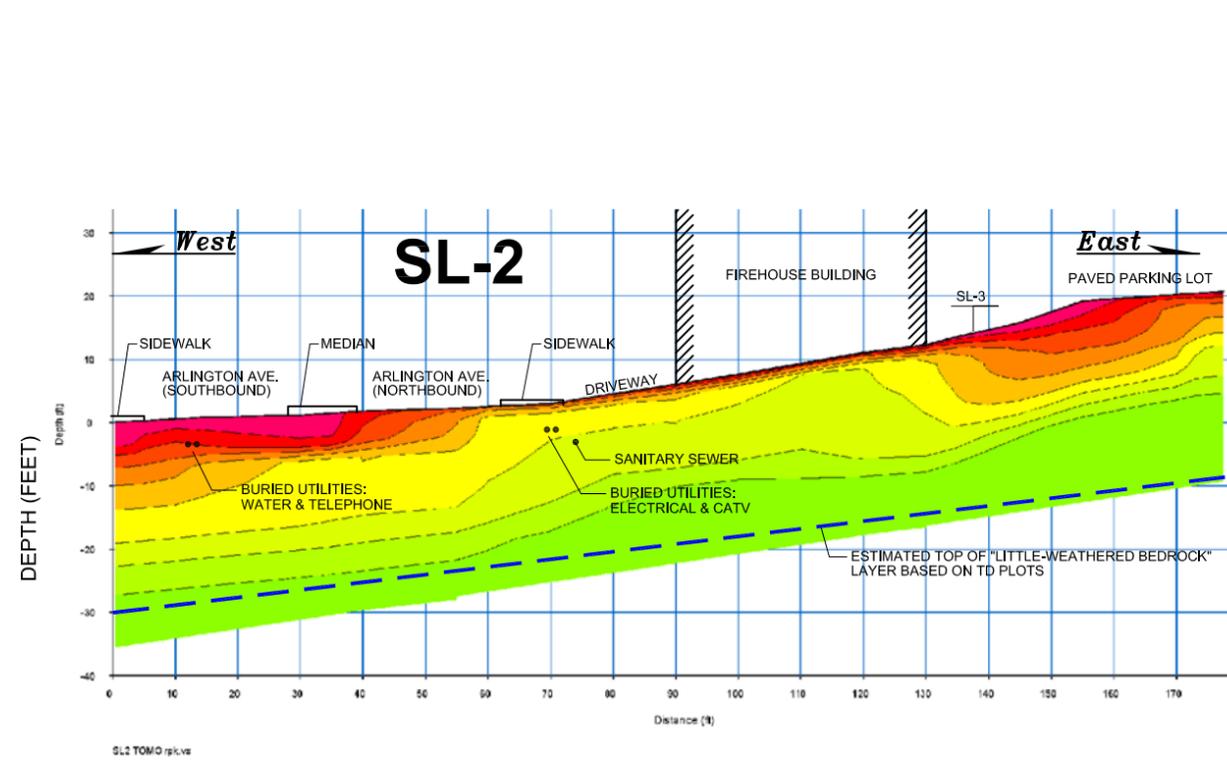
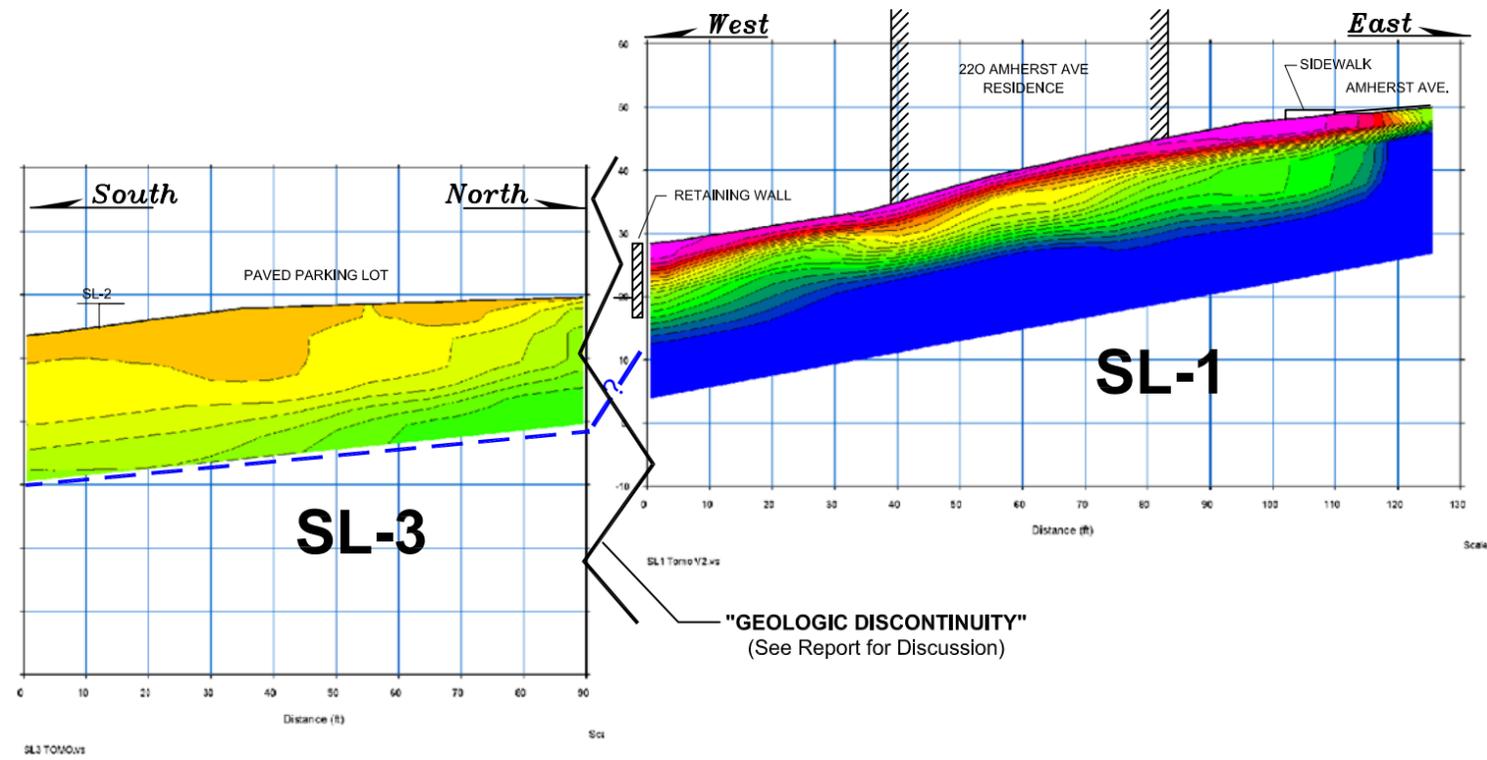
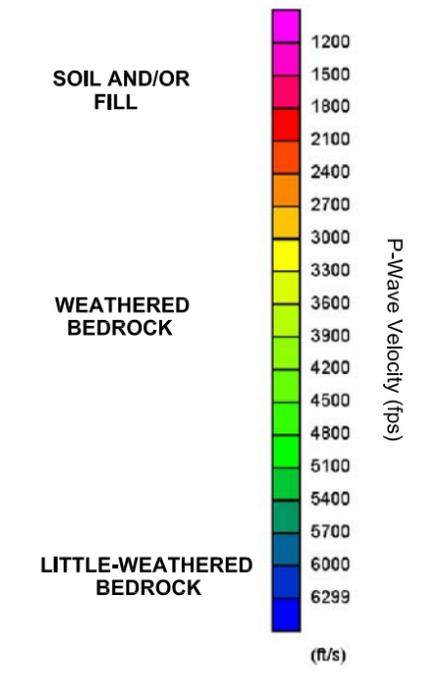
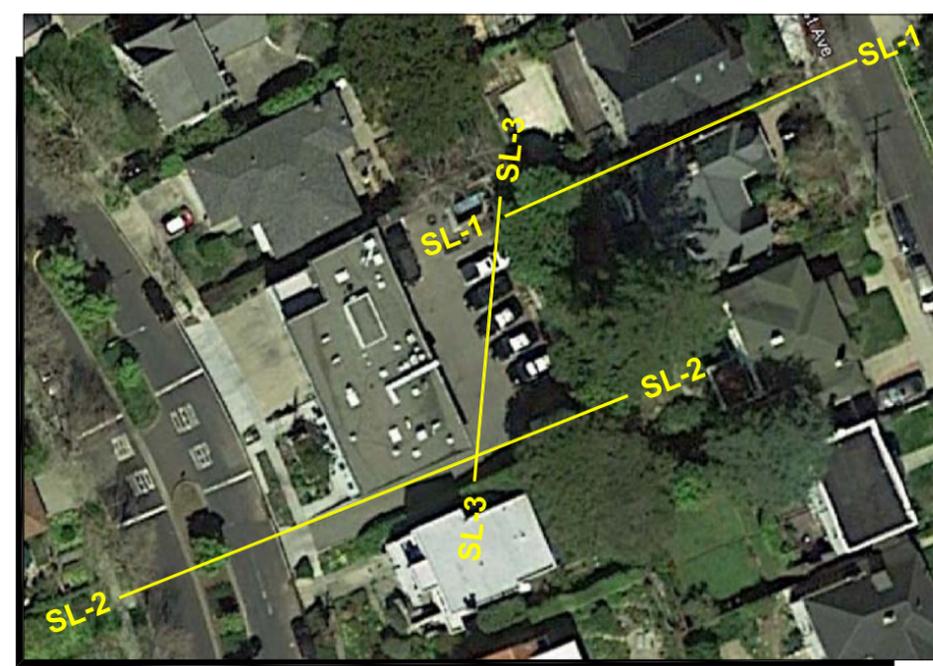
- No definitive fault indications were observed in the seismic or GPR survey results. It is worth noting, however, that SL-1 exhibits different subsurface conditions than SL-2 and SL-3, which suggests there may be a geologic discontinuity at the gap between SL-1 and the other the two seismic lines (i.e., along the retaining wall between the back of the public safety building parking lot and the neighbor's yard).

- Specifically, SL-1 (in the neighbor's backyard) shows higher-velocity material ("bedrock") in the shallow subsurface, compared to SL-2 and SL-3. This result could simply mean that, as a result of erosion, bedrock is closer to the surface in the topographically higher portion of the site, or it may indicate a change in bedrock attitude (e.g., dip in bedding) that causes bedrock to be deeper towards the west. Or, the absence of the higher-velocity "bedrock" material in the SL-2 and SL-3 models could indicate that earth movement along a fault or slide plane dropped the bedrock layer below the investigation depth limits of the refraction survey.

It is worth noting, however, that SL-1 exhibits different subsurface conditions than SL-2 and SL-3, which suggests there may be a geologic discontinuity at the gap between SL-1 and the other two seismic lines (i.e., along the retaining wall between the back of the public safety building parking lot and the neighbor's yard). Specifically, SL-1 (in the neighbor's backyard) shows higher-velocity bedrock in the shallow subsurface, compared to SL-2 and SL-3. This result could simply mean that, as a result of erosion, bedrock is closer to the surface in the topographically higher portion of the site, or it may indicate a change in bedrock attitude (e.g., dip in bedding) that causes bedrock to be deeper towards the west.

Since the suspected fault feature located beneath or behind the 12-foot high retaining wall cannot be effectively investigated with an open trench at this time, we recommend the discontinuity observed at the eastern property line be considered as an active fault or fault splay for planning purposes. This assumption is consistent with suggested fault and fault splays shown on regional geologic maps. Therefore, for planning purposes, we recommend a 50-foot setback from the suspected fault feature at the eastern property line; this setback distance can be modified (i.e. increased or decreased), as appropriate, based on geologic features exposed in a fault trench excavated through the eastern property line.
