January 31, 2018
Project No. 17-1381

Subject: Preliminary Fault Investigation
Proposed Kensington Essential Services Building
217 Arlington Avenue
Kensington, California

Subject: Geophysical Investigation Results
Kensington Public Safety Building
217 Arlington Avenue
Kensington, California

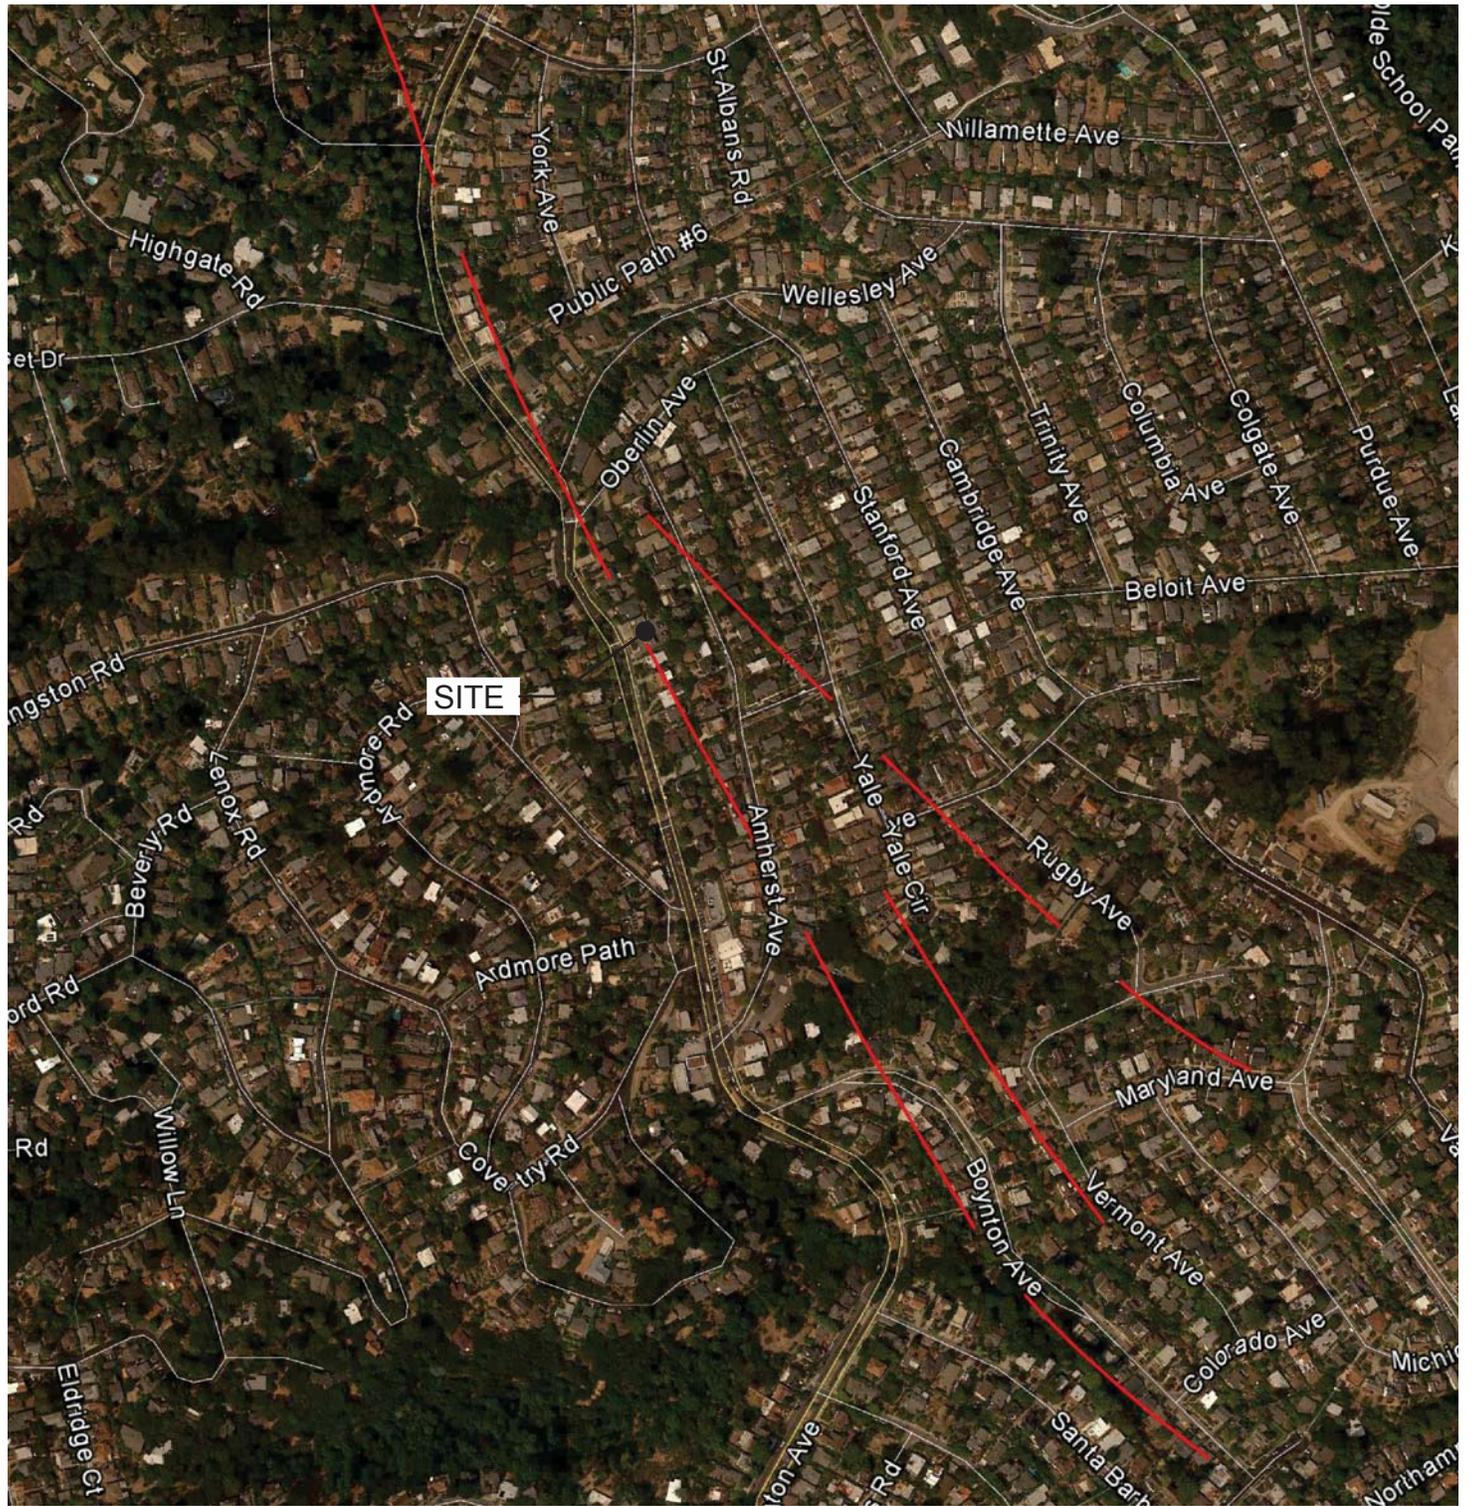
Figure 5

suspected fault splay upslope of the site near Amherst Way. The geologic map by Dibblee and Minch (Figure 4) also shows three faults near the site, with two (including the main trace) downslope and another suspected splay upslope of the site. The U.S. Geological Survey maintains a data server called the Quaternary Fault and Fold Database (QFFD) that shows the approximate locations of faults in the region. The QFFD (Figure 5) shows two faults, with one fault crossing the center of the site and a fault just upslope of the site above Amherst Way. Note that the QFFD is registered to Google Earth images and are approximate. Additionally, the Tri City Seismic Safety Element report (Figure 6) also shows three faults, with one fault along Arlington Avenue, one fault to the west below Arlington Avenue, and one fault upslope of the site near Yale Avenue.

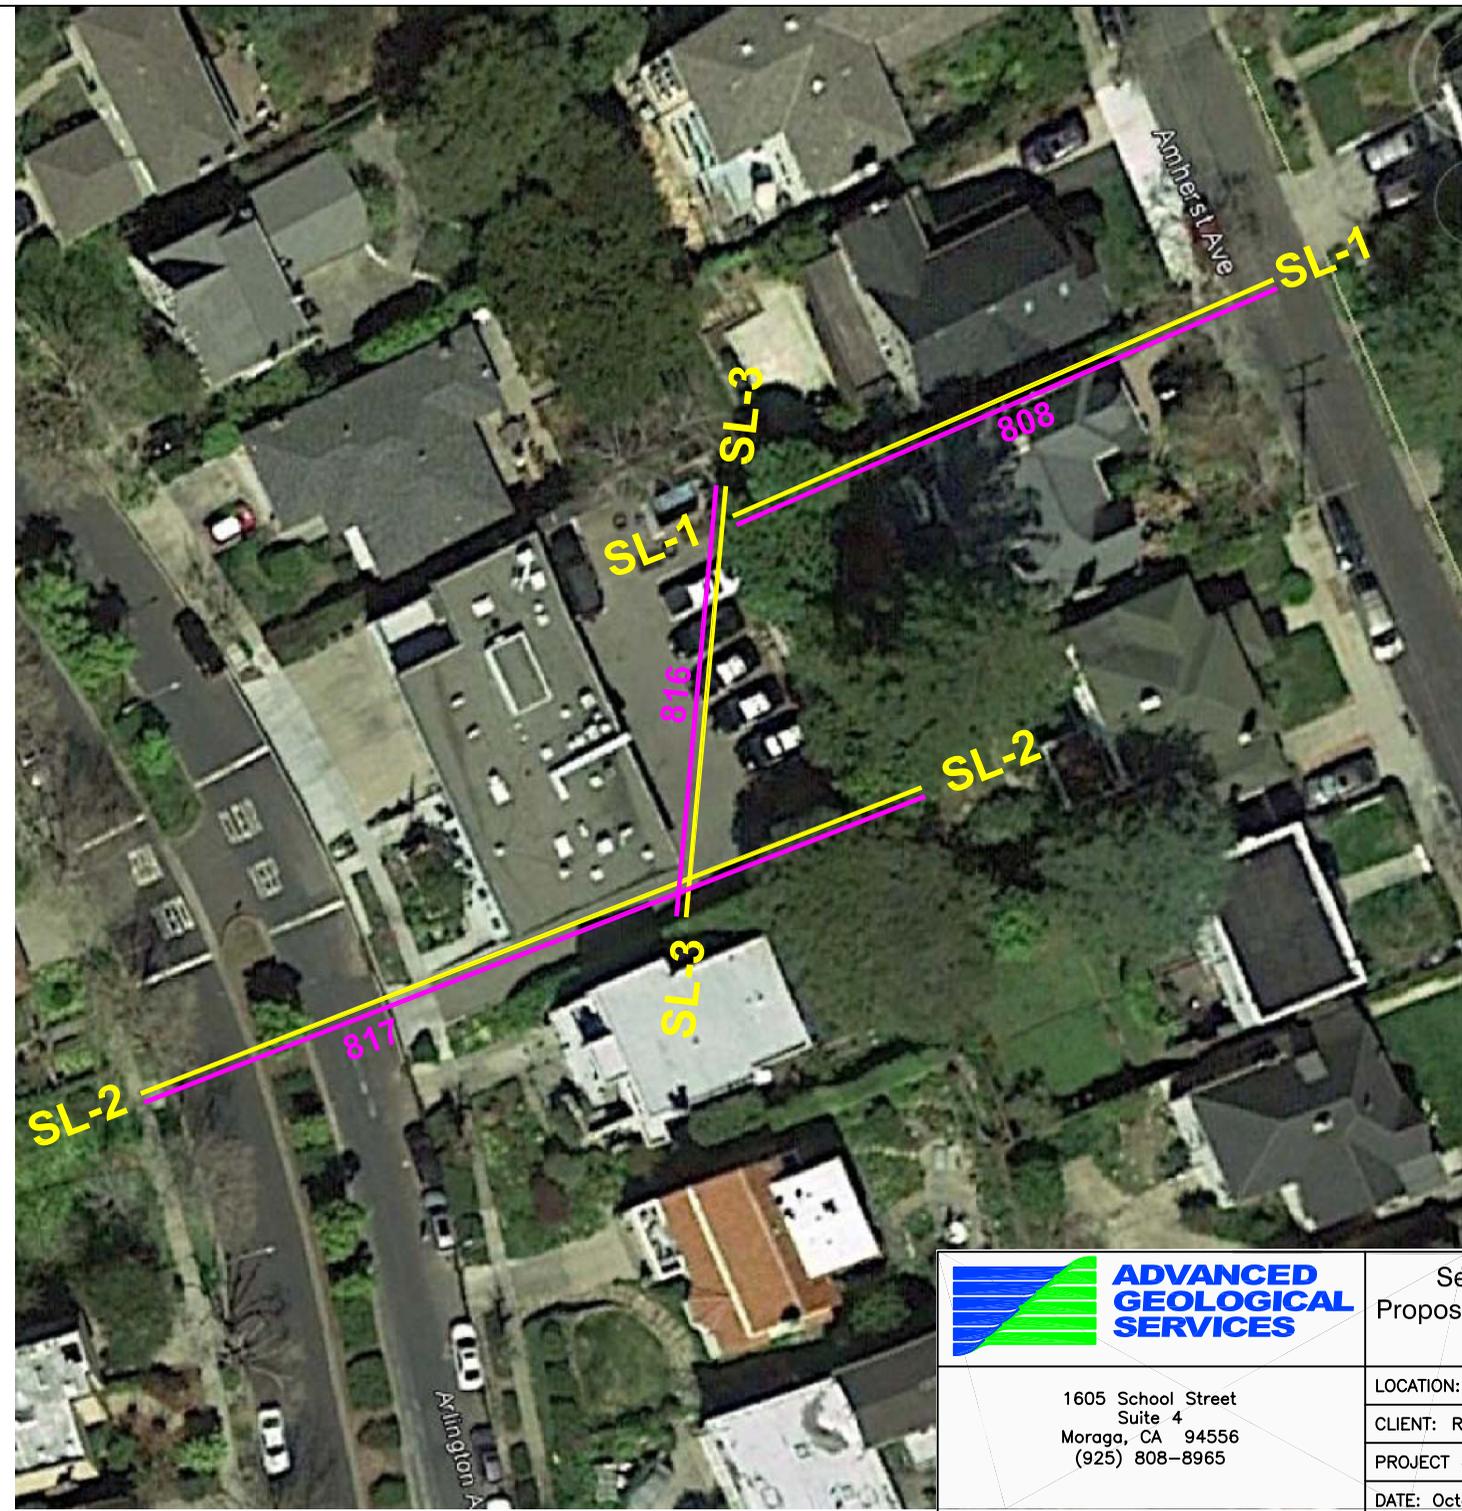
The surveys were performed along three lines— one that extended across Arlington Avenue and up the driveway alongside the existing public safety building (SL-2), a second running diagonally across the parking lot behind the building (SL-3), and a third through the neighbor's backyard east of the public safety building (SL-1).

AGS performed the GPR survey by wheeling the cart-mounted GPR system along the same lines as the seismic survey (Figure 2). Using the system’s viewing screen to monitor the data as the survey progressed, the GPR profiles were inspected in the field for lateral discontinuities in layering that could indicate recent movement along a fault.

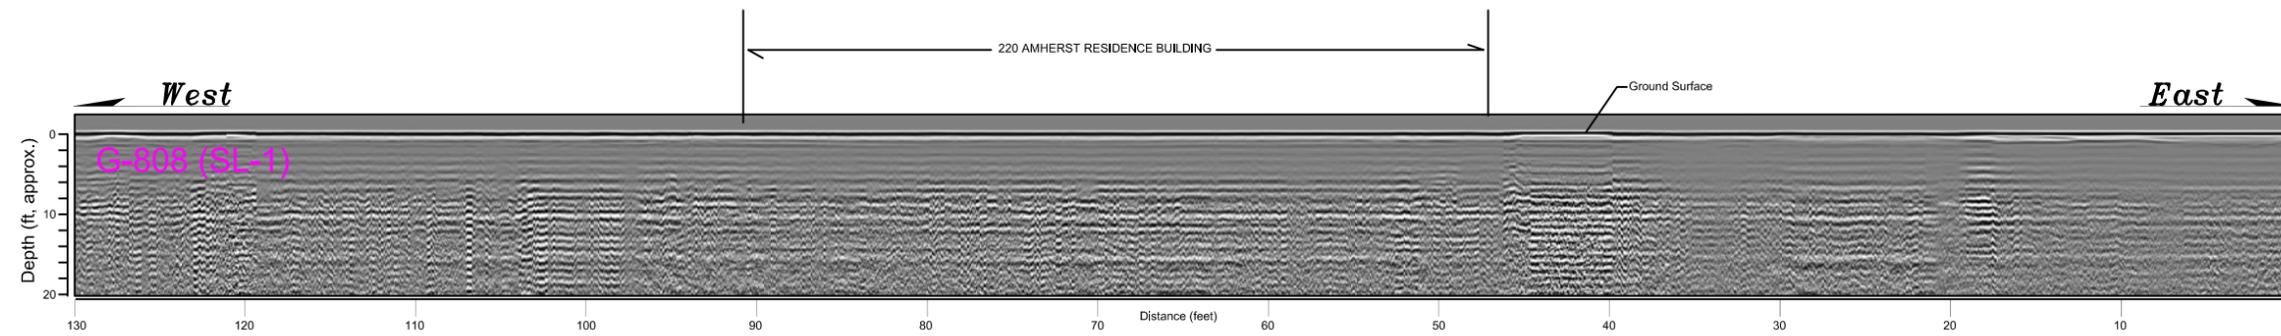
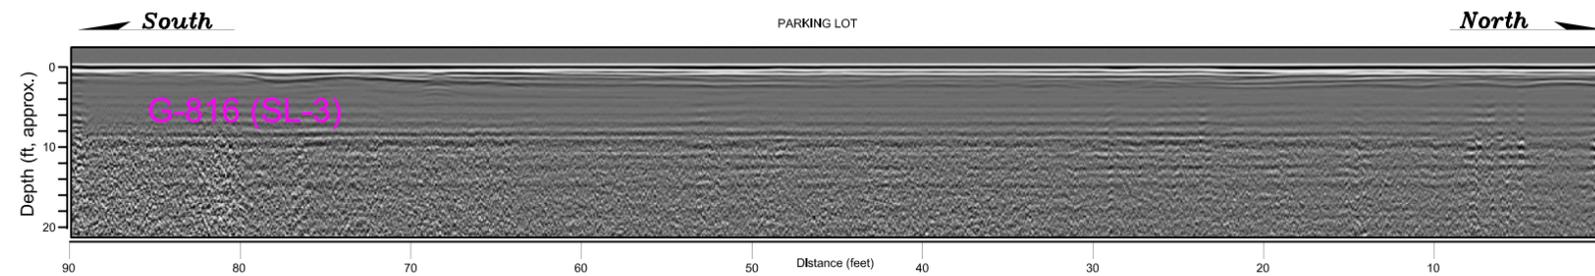
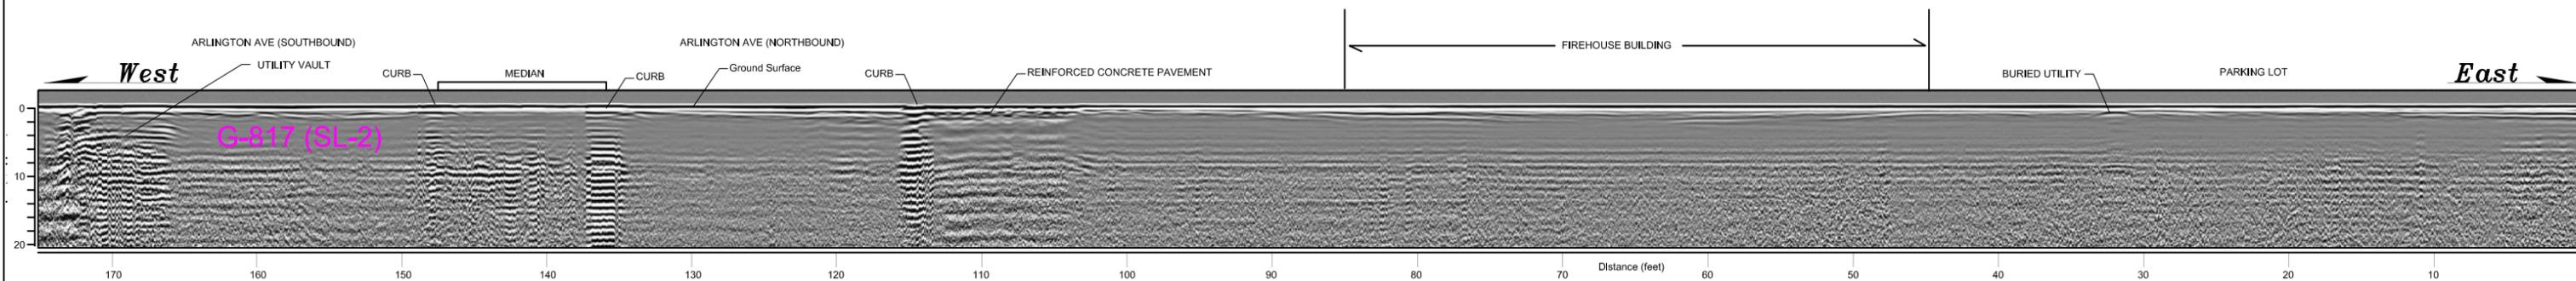
A sudden change in bedrock and an apparent discontinuity in the subsurface conditions suggest the possible presence of a fault at that location. The possible presence of a fault at the eastern property boundary would coincide with previous mapping of a suspected fault upslope of the site as shown on the five geologic maps previously referenced (Figures 3 through 7). Therefore, based on available geologic information and the results of the geophysics survey, we judge the discontinuity at the eastern property line to be a fault that matches the regionally mapped conditions.
