**BIGGS CARDOSA
ASSOCIATES INC**
STRUCTURAL ENGINEERS

Kensington Fire Station Seismic Assessment

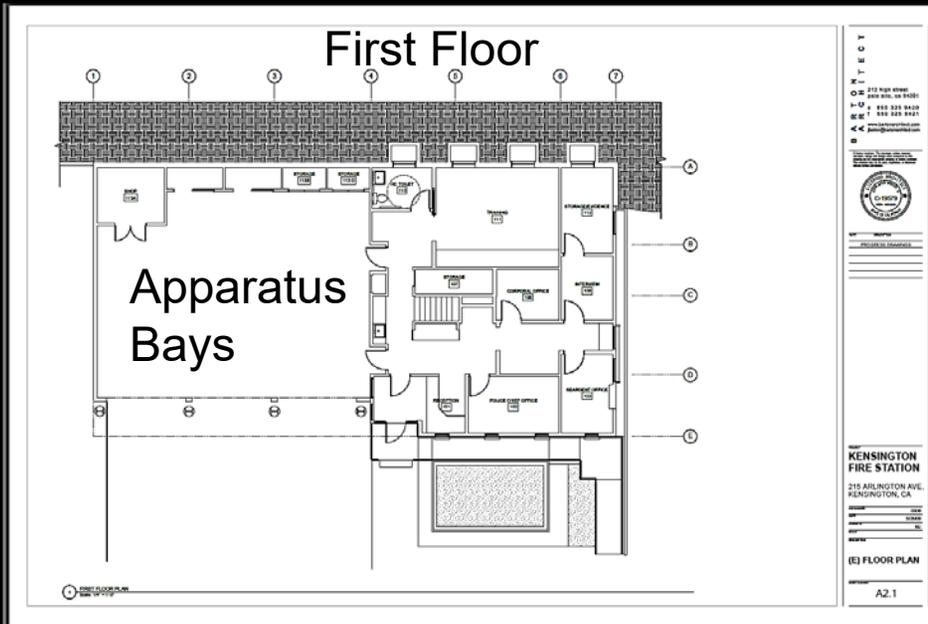
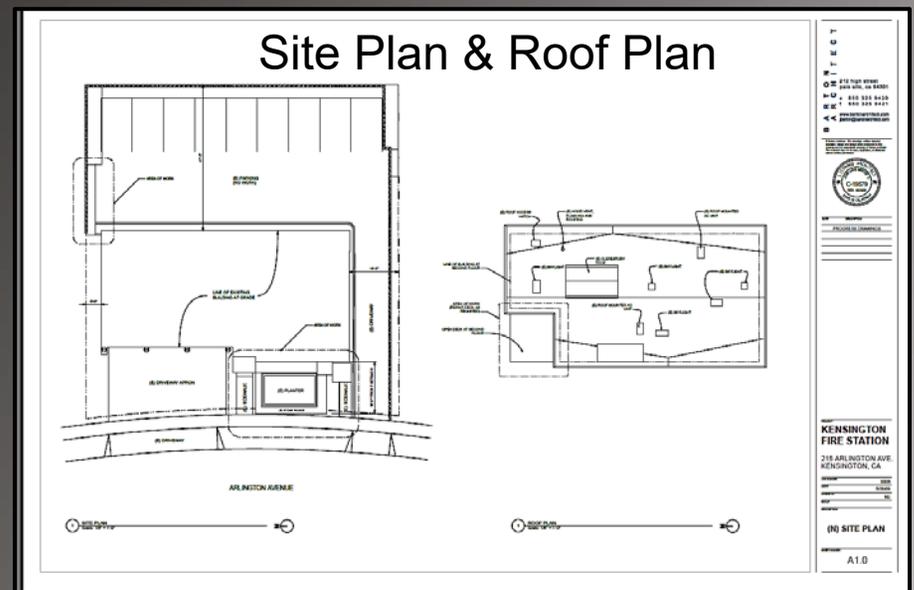
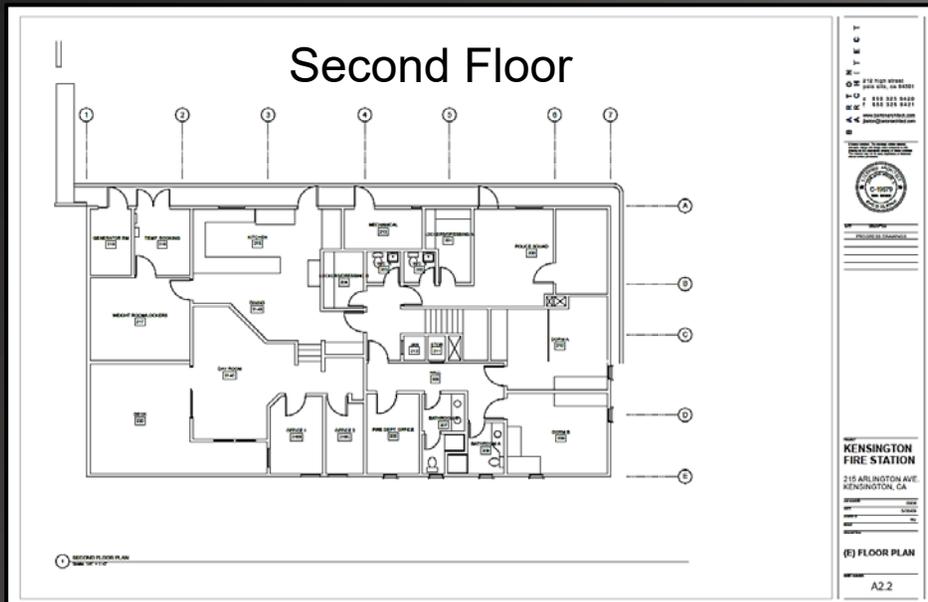
BUILDING HISTORY

Built in 1969, 5800 S.F., 2 story police & fire station building was built on sloping ground.

- Ground floor level has a rear partial basement, retaining walls & three apparatus bays
- Second Floor is made of wood & steel members & plywood diaphragm
- Roof is made of wood members and plywood diaphragm
